# **X-38 De-orbit Propulsion Stage MLI Performance Test**

Sept 10-14, 2001

Ken Kittredge  
NASA/MSFC

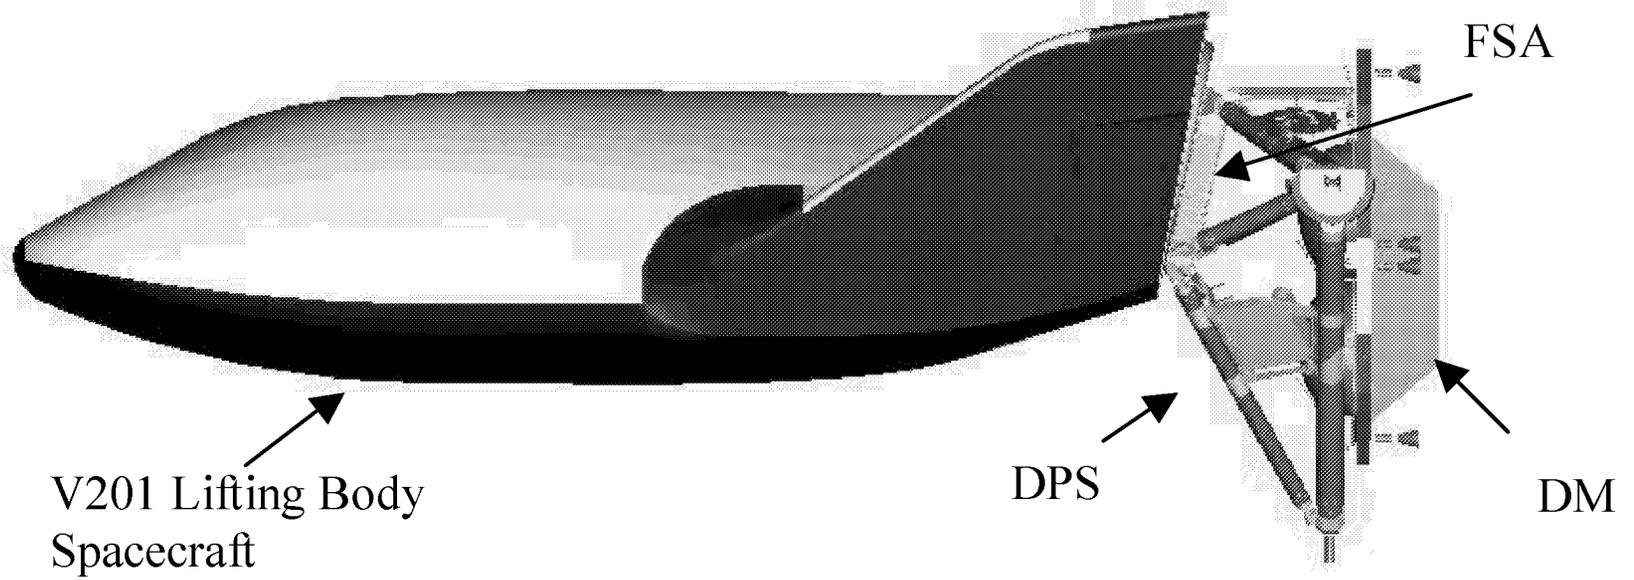
# X-38

- X-38 is Pathfinder for Space Station Crew Return Vehicle
- X-38 Launched in Space Shuttle
- De-Orbit Propulsion System (DPS) Maneuvers X-38 in Descent Trajectory and is Jettisoned Prior to Re-entry
- X-38 DPS design hot biased to reduce power and energy requirements
- Black Beta Cloth selected as outer layer on MLI
- Analytical Margin is Small and no DPS Thermal Testing Planned.

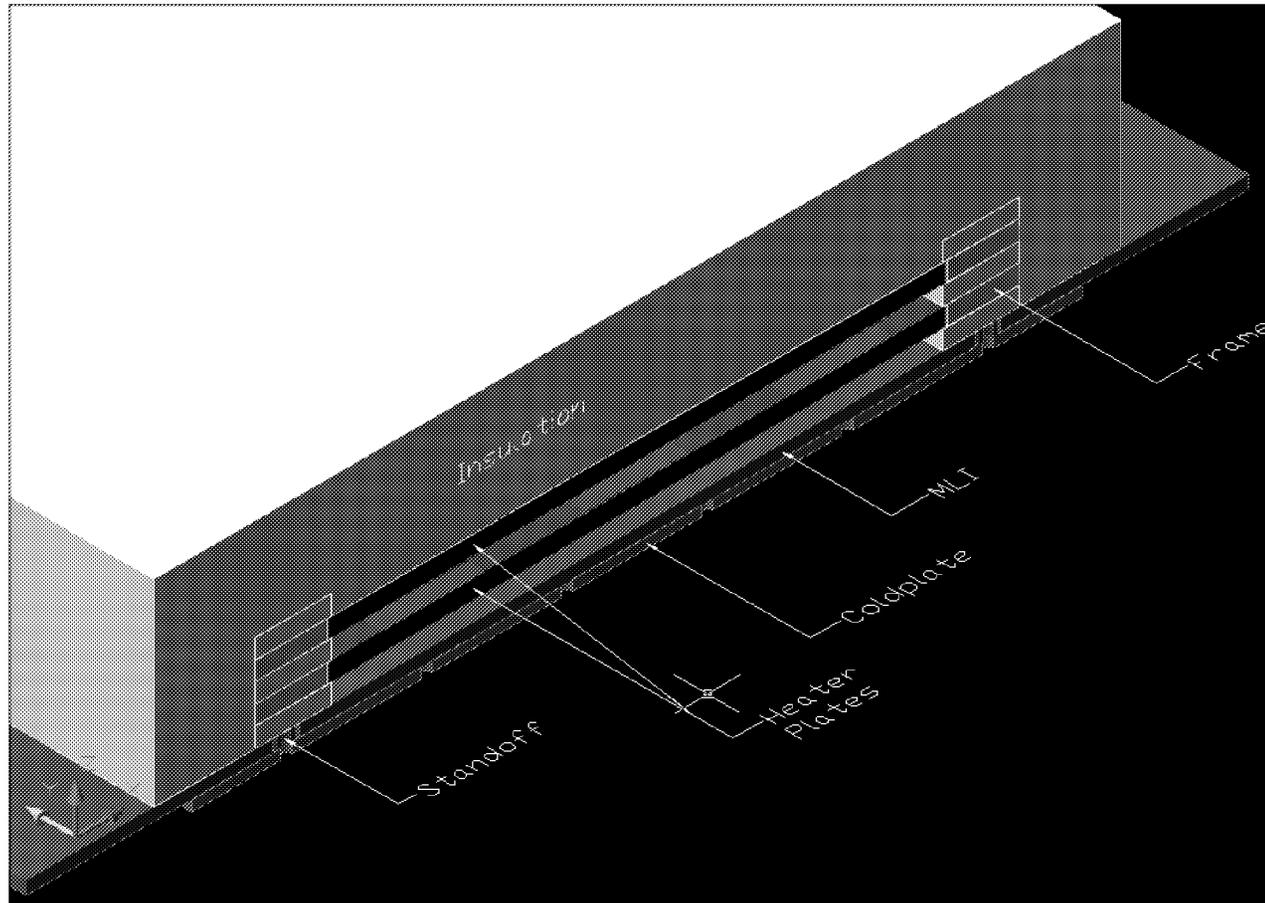
# Test Fixture Cross-Section

- Test Fixture Composed of Polysulfone Plastic Frame and two Black Anodized Aluminum Heater Plates
- Mounted to Space Station –1 Coldplate with Teflon Isolators
- Insulated with four inches of Cryolite Fiberglass Matte
- MLI Sandwiched in Interface Between Heater Plates and Coldplate
- One Square Foot Test Area

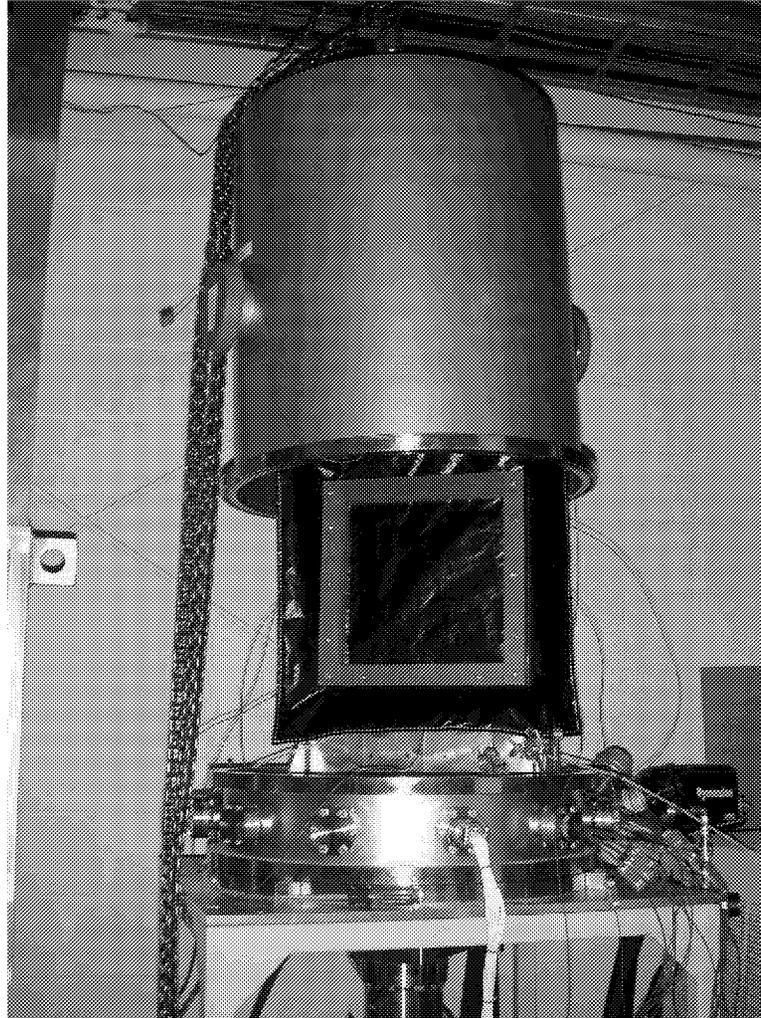
# Test Setup

- 9 Minco Thermofoil Heaters per Heater Plate
- Temperature Sensors Mounted on Heater Plates, Coldplate, Frame, and Chamber Shell
- Fixture Isolated from Coldplate with Teflon Standoffs
- MLI Between Test Fixture and Coldplate
- Vacuum Chamber
- Johns Manville Cryo-lite Fiberglass Insulation
- ISS -1 Coldplate and Neslab Low Temperature Chiller
- Residual Gas Analyzer
- DAQ System and Power Supplies

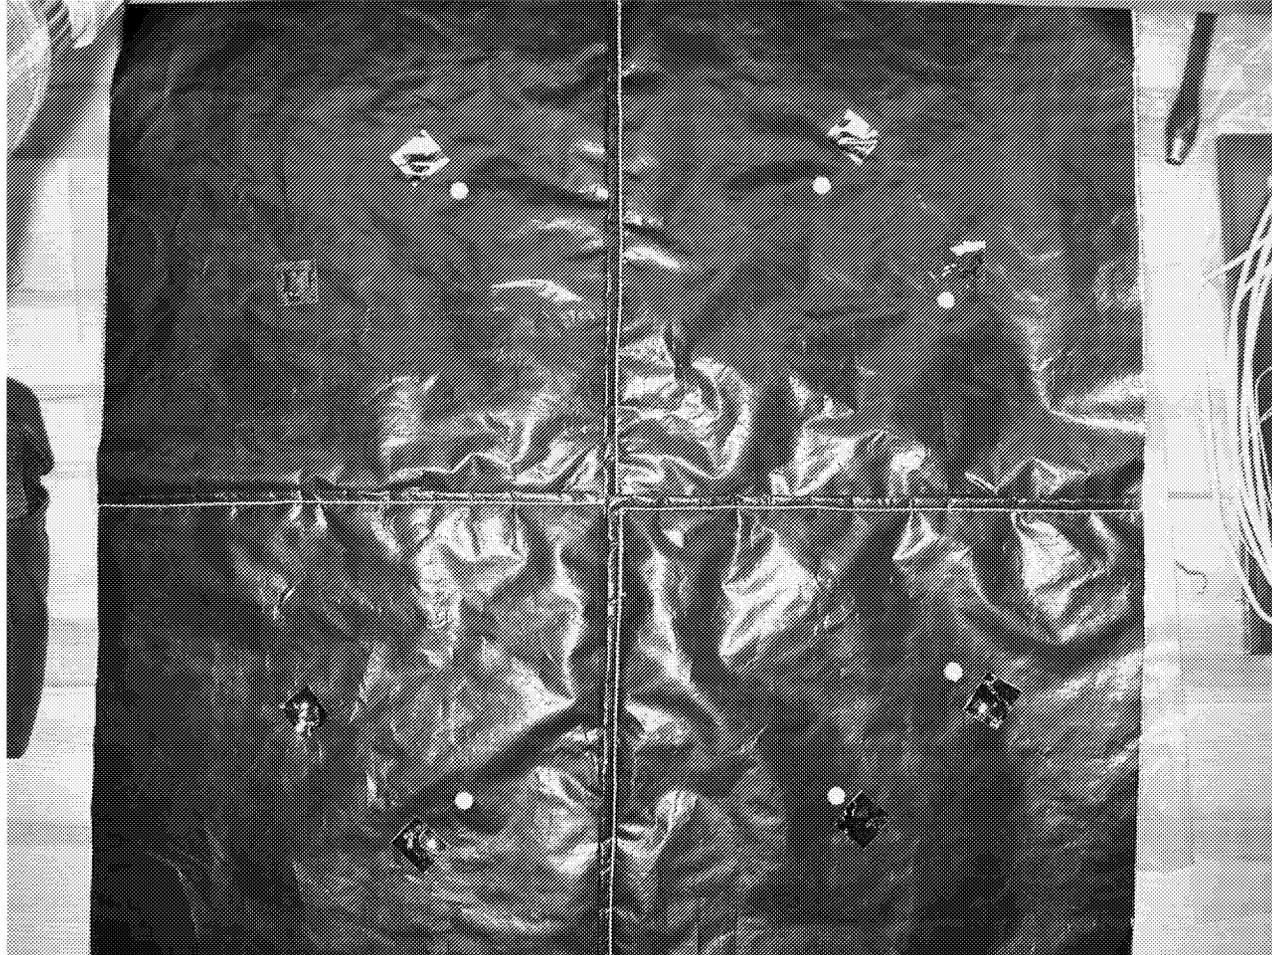
## MLI Configuration for Seam Test

- Removed MLI from Test Fixture and Quartered it.
- Each Piece was then Reversed and laid out so the Seams of Adjacent Pieces Overlap then Taped in Place
- 8 RTD's added to MLI side of Test Fixture Frame.
- Configuration then Reassembled.

- Primary Heater Temperature of 295°F and Coldplate Temperature of 22.1°F yielded  $\varepsilon^*$  of 0.044 based on full Heat Load of 19.1 btu/hr across MLI
- Assessment of Test Results Indicates much more Heat Leak from Test Fixture than Expected Causing Over-Estimation of  $\varepsilon^*$
- Frame Temperatures of 235°F Appreciable Higher than Expected
